Crack Bridging Properties of PCS-355

By:
Lee Bower
President, PCSI

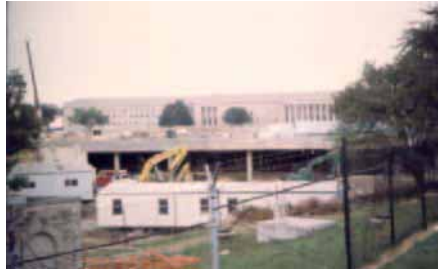
Photo 1

The Pentagon recently constructed a 280,000 ft² concrete structure to serve as a remote delivery facility (RDF) for services and goods provided to the Pentagon office facilities. The RDF is located below grade and constructed as a directed blast structure to provide security to the Pentagon proper in the event of a directed attack by way of incoming goods. The roof of the deck will be backfilled and developed into a park atmosphere with grass, plants, trees, and esplanade. Figure 1 shows the surface of the RDF.

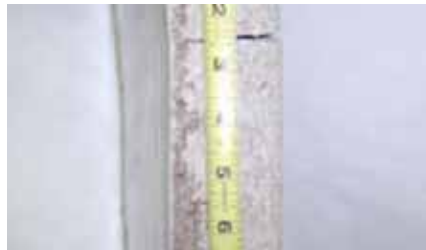
Photo 2

was inserted into an Instron type tensile instrument by the eye hooks. Tension was put on the block to secure the apparatus and zeroed. Ambient temperature was 77 °F. Figure 2 shows the block in it's initial stage prior to pulling on the crack.

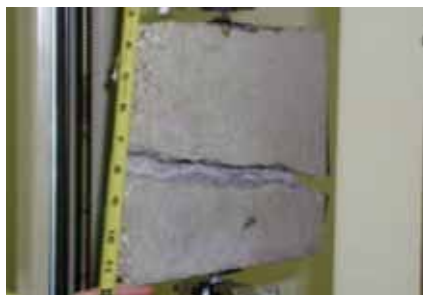
Photo 4 shows the gap at 1".

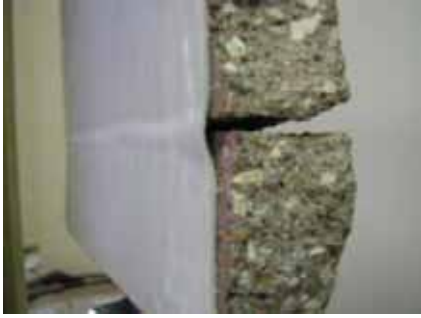
Close inspection of the PCS-355/ PCS-30 system membrane showed no cracks, tears, or loss of adhesion along the shoulders of the crack. Photo 5 shows the block and membrane in it's initial state after repeated stretching to 1".
